# **INDOOR AIR QUALITY ASSESSMENT**

**Halifax Elementary School  
Silver Lake Regional School District  
464 Plymouth Street  
Halifax, Massachusetts**

Prepared by:  
Massachusetts Department of Public Health  
Bureau of Environmental Health Assessment  
April, 2002

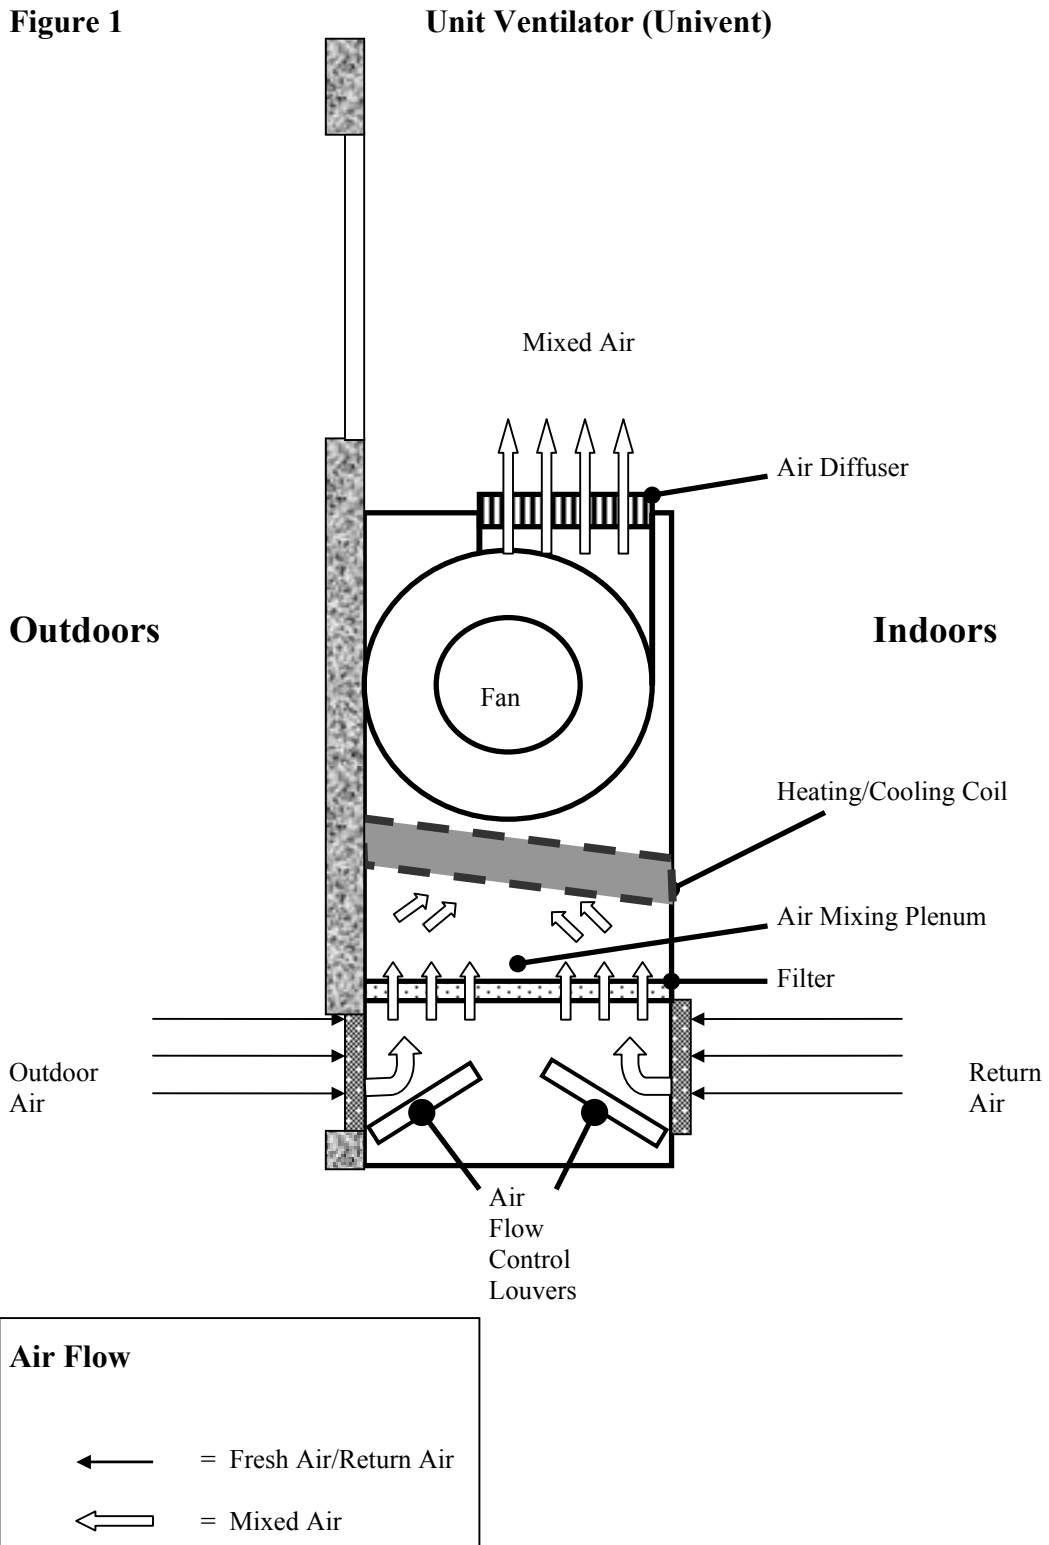
**Figure 1**

Fresh air in classrooms is supplied by a unit ventilator (univent) system (see Picture 1). Univents draw air from outdoors through a fresh air intake located on the exterior walls of the building (see Picture 2) and return air through an air intake located at the base of each unit. The mixture of fresh and return air is drawn through a filter and heating coil, and is then expelled from the univent by motorized fans through fresh air diffusers on the top of each unit ([see Figure 1](#)).
